Manhole Inspection Summary

Manhole # S27M__006MH

Inspection ☐ Is Incomplete Rating: **4) Poor**

Location Address: **1167 W Ostend**

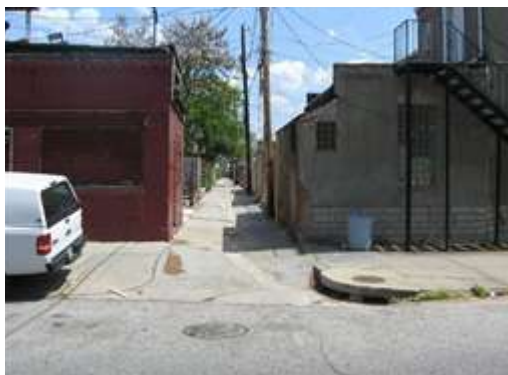
Location View

In front of 1167 W Ostend

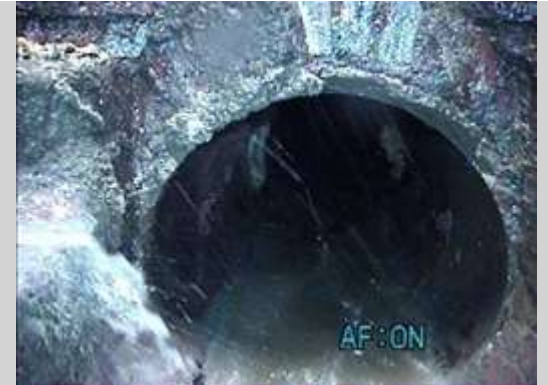
12 O'Clock Outflow

24 in. Circular Gravity Sewer
Pipe Out @ 12 O'Clock

Pipe Height: **24** (in.) Rod and Bar (Angled)
Pipe Material: **Clay** ☐ Pipe Lined
Invert Depth: **13.87** (ft.) Flow Characteristics: **Fast**
Deposits: ☒ None ☐ Mud ☐ Sludge ☐ Debris ☐ Grease
Silt Depth: **0** (in.) Deposits Extent:
Infiltration: **Evidence** Pipe Seal Cond: **Sound**

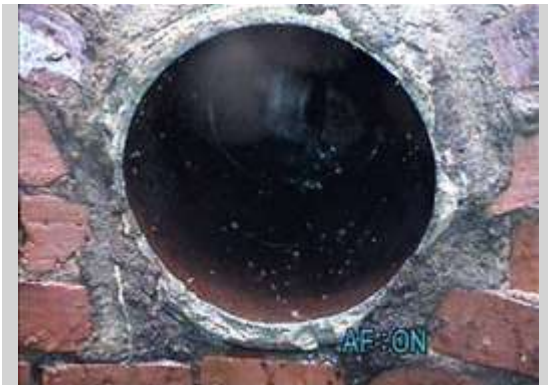
3 O'Clock Inflow

10 in. Circular Gravity Sewer
Pipe In @ 3 O'Clock

Pipe Height: **9.6** (in.) Rod and Bar (Angled)
Pipe Material: **Clay** ☐ Pipe Lined
Invert Depth: **8.91** (ft.) Flow Characteristics: **Slow**
Deposits: ☒ None ☐ Mud ☐ Sludge ☐ Debris ☐ Grease
Silt Depth: **0** (in.) Deposits Extent:
Infiltration: **Evidence** Pipe Seal Cond: **Unknown**

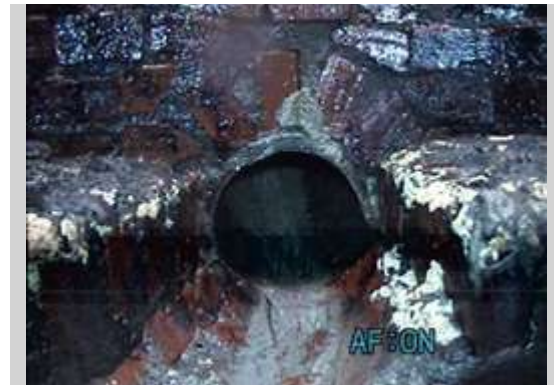
Drop In @ 3 O'Clock

Drop: **Outside** Rod and Bar
Angled: **Yes** Reading: **10.94** (ft.)
Inv Depth: **11.94** (ft.)
Drop Condition: **Open**
